Full-Scale Evaluation of DuraDeck® and MegaDeck™ Matting Systems

Timothy W. Rushing and Lyan Garcia

July 2013

Final report

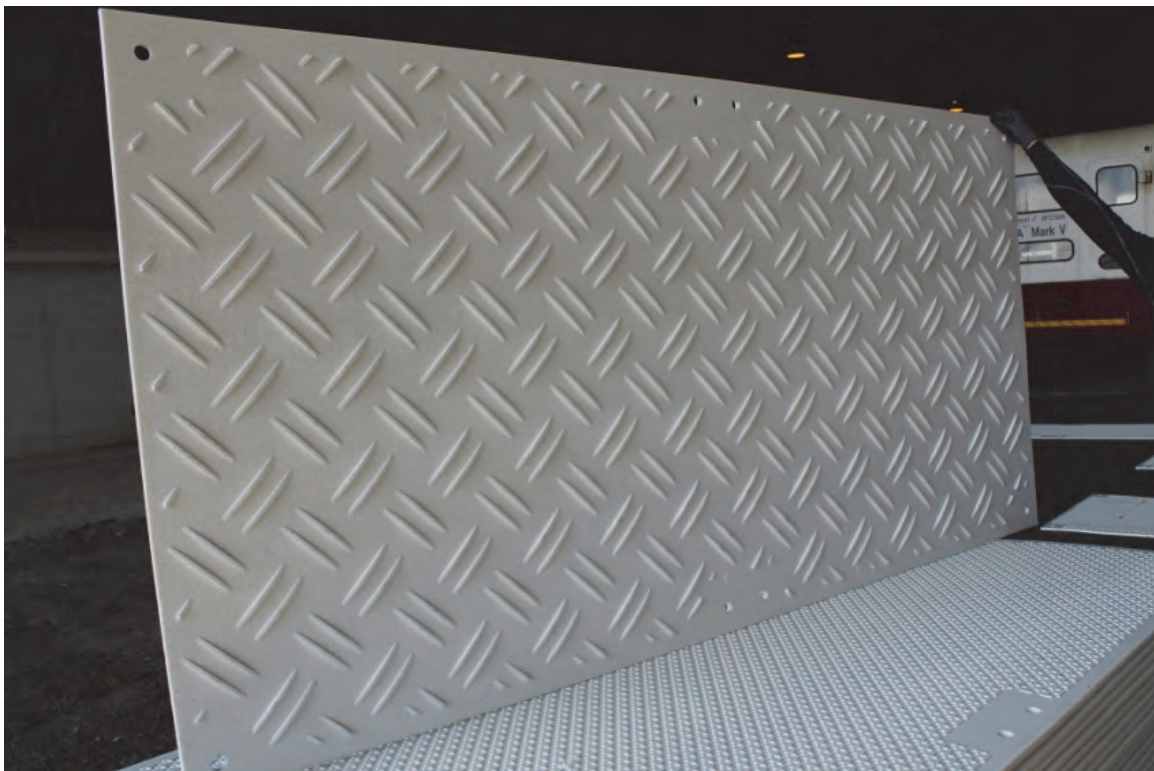
Figure 2. DuraDeck® mat panel, bottom surface.

The DuraDeck® matting system, shown in Figures 1 and 2, is made up of 4-ft-wide-by-8-ft-long-by-0.625-in.-thick panels. These panels come in standard colors of white, black, and sand, but can be customized. The panels are constructed of a proprietary blend of high-density polypropylene (HDPE) plastic that is compression-molded into a solid panel with a non-skid surface molded onto each face. Each panel weighs 86 lb and can be installed by two men without the assistance of material handling equipment (MHE). Panels are connected by placing metal plates studded with threaded

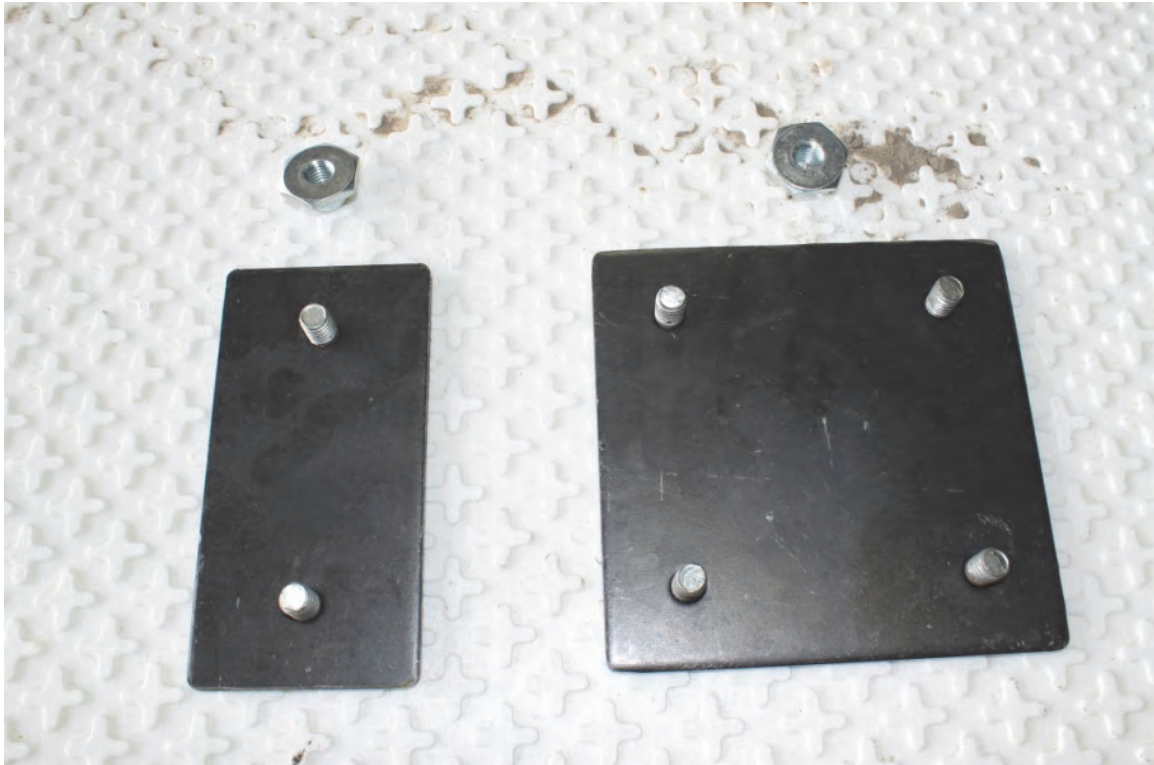
Figure 3. DuraDeck® metal plates and connector nuts.

bolts, as shown in Figure 3, underneath the mat corners and then installing special connector nuts from the top surface to secure the mats together. According to the manufacturer, the panels will not degrade with sun or aircraft fluid exposure. If anchoring is required by the user, COTS duckbill anchors are recommended to keep the surface from moving during operations; however, anchoring is not required by the manufacturer.

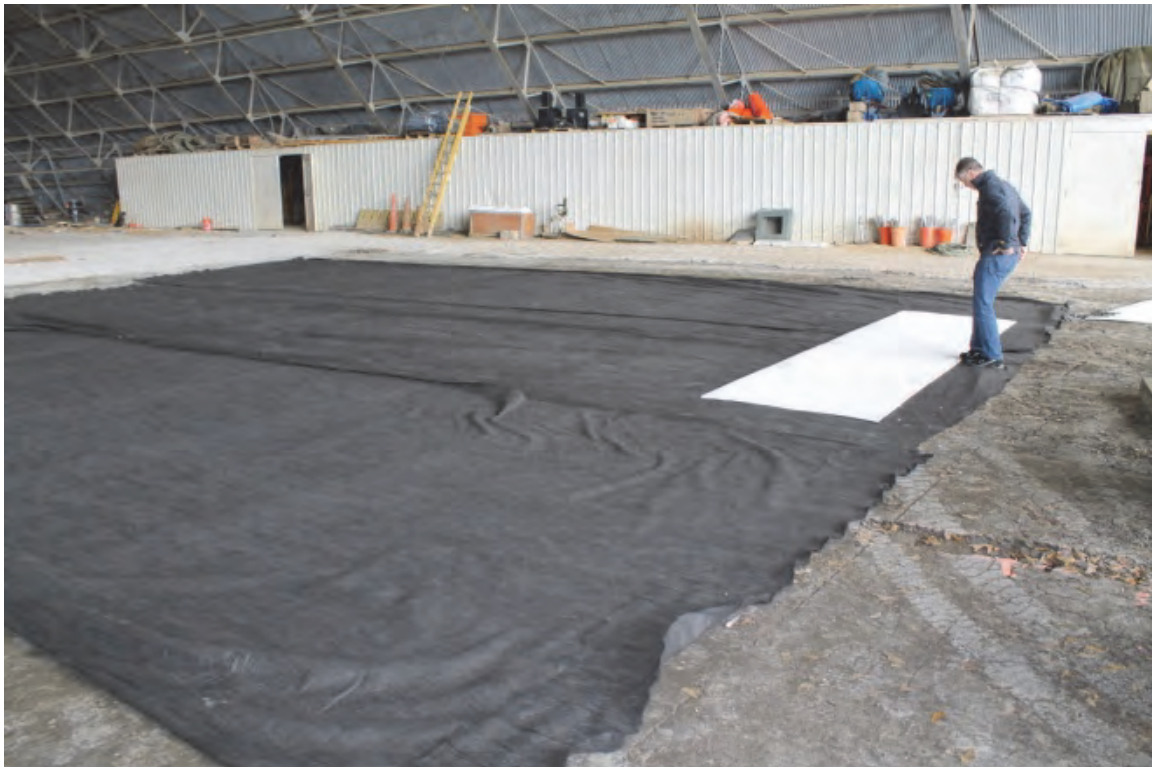
Figure 7. Geotextile-covered test bed.

According to the manufacturer, the DuraDeck® matting system performs best over soft, fine-grained soils when a geotextile fabric is installed on the soil surface (DuraDeck® Installation, n. d.). A standard, non-woven needle-punched geotextile was recommended. The geotextile keeps soil from coming through the panel joints and working its way onto the panel surface. The geotextile also offers some tensile resistance to reduce the permanent deformation in the subgrade. A 12.5-ft-wide by 360-ft-long roll of 6-oz. non-woven geotextile was acquired for the evaluation. The roll weighed approximately 120 lb and had a diameter of about 18 in. Three 40-ft-long sheets of geotextile were cut from the roll and placed side-by-side with 12-in. overlaps on the CH test bed prior to mat installation as shown in Figure 7.

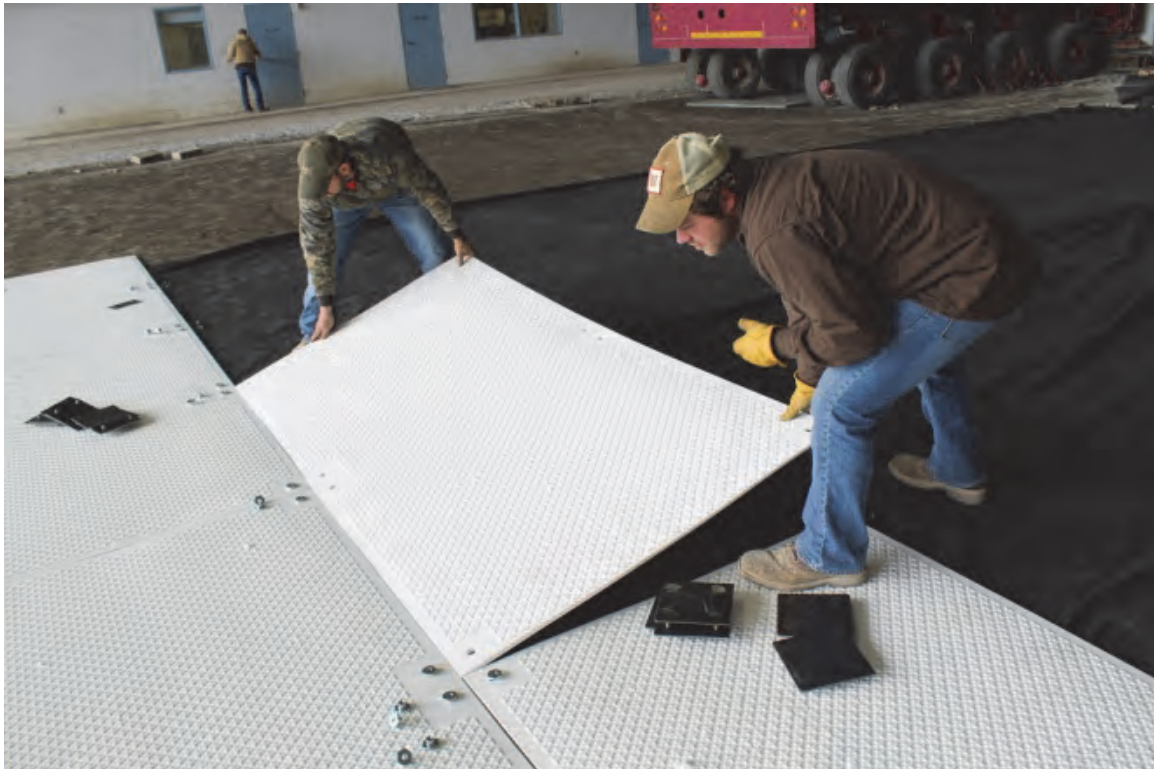
Figure 8. DuraDeck® panel installation.

underneath two pre-drilled corners of the panel. The plates were positioned so that the adjacent panel's opposite pre-drilled corners lined up over two other threaded studs on the same plates, allowing the panels to be connected. Once the second panel was positioned over the threaded connectors, nuts were installed on the threaded studs from the top side of the panels to fasten them securely. This process was continued until the entire panel array was complete. Each of the connector nuts was hand-started, then tightened using a cordless drill with a socket designed to fit the nuts. During installation, the manpower was divided as follows: two men carried the panels into position and aligned the bottom connector plates, two men hand-started connector nuts, and one man tightened the nuts with a cordless drill. After one hour of installation, the array of panels was complete. Assembly time was calculated and resulted in approximately 320 ft²/man-hr. Greater efficiency could have been gained by using a second cordless drill for tightening the connector nuts. Eight nuts were required for each interior panel, and six were required for edge panels. Half-panels were not used for this test; however, they are available from the manufacturer to ensure a square or rectangular array can be assembled with complete coverage of the area. Photos demonstrating installation of the DuraDeck[®] panels and the final layout of the test section are shown in Figures 8 through 11.

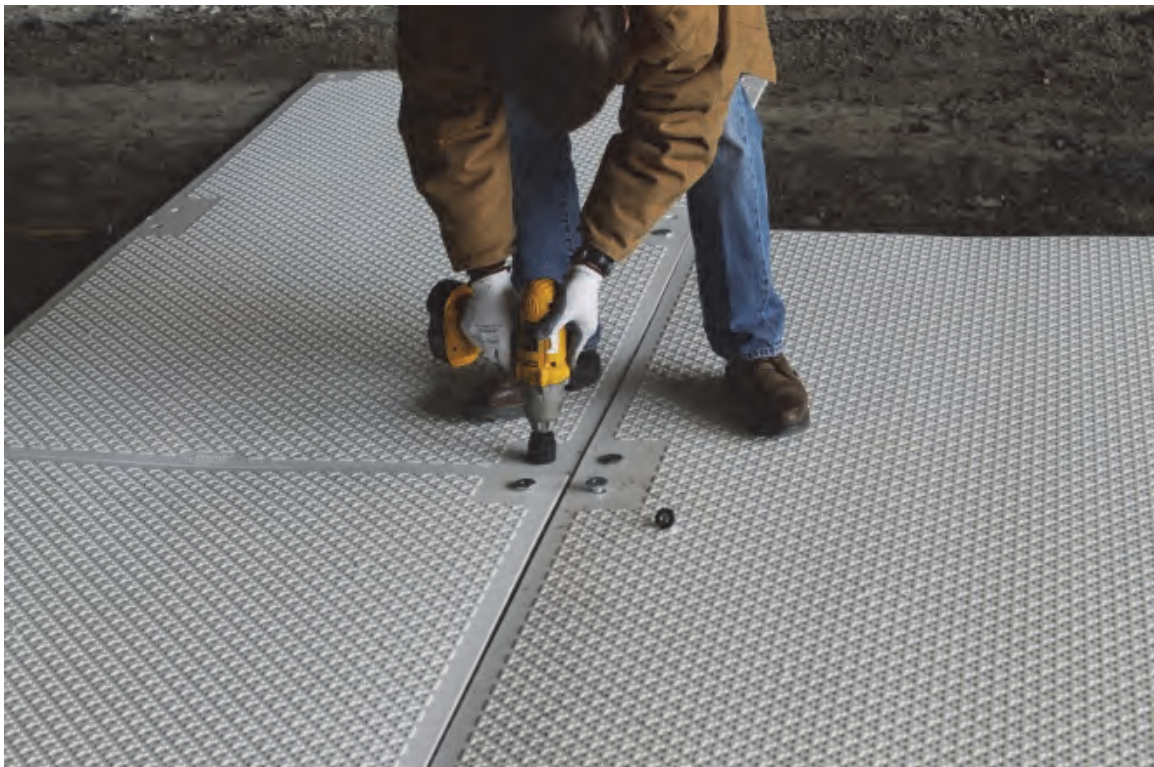
Figure 9. Tightening DuraDeck® connector nuts.

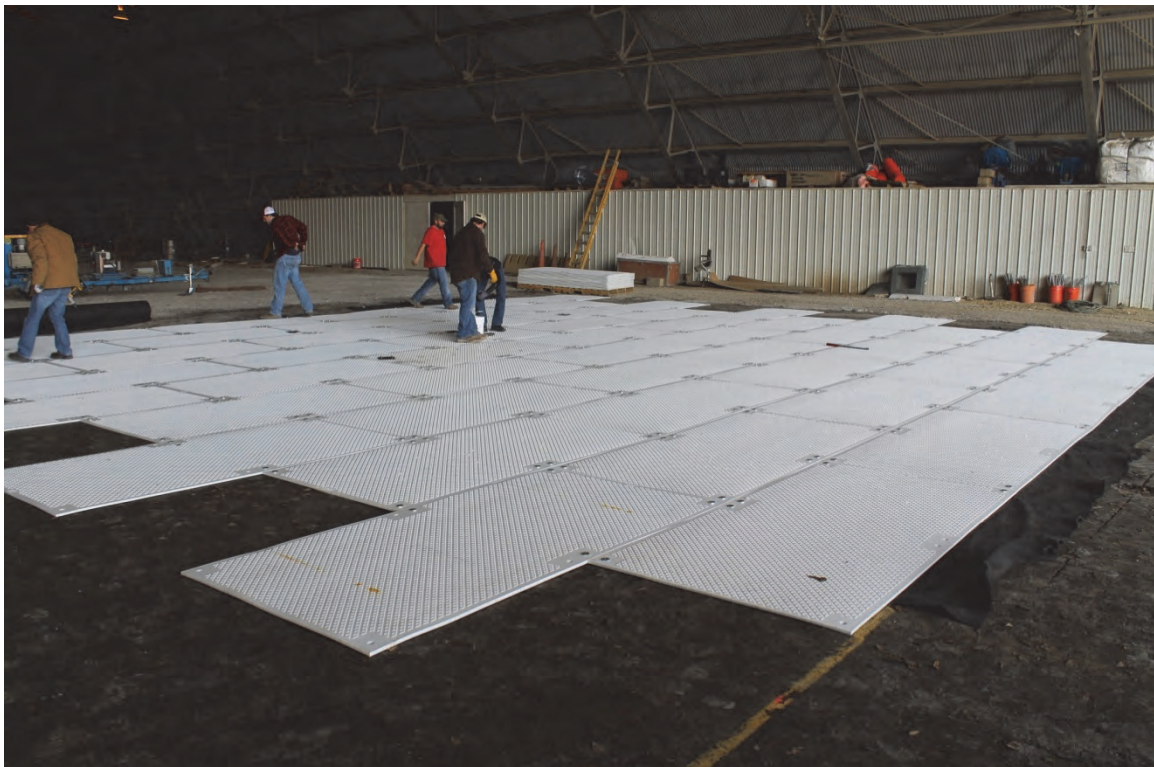
Figure 11. Final layout of DuraDeck® test section.

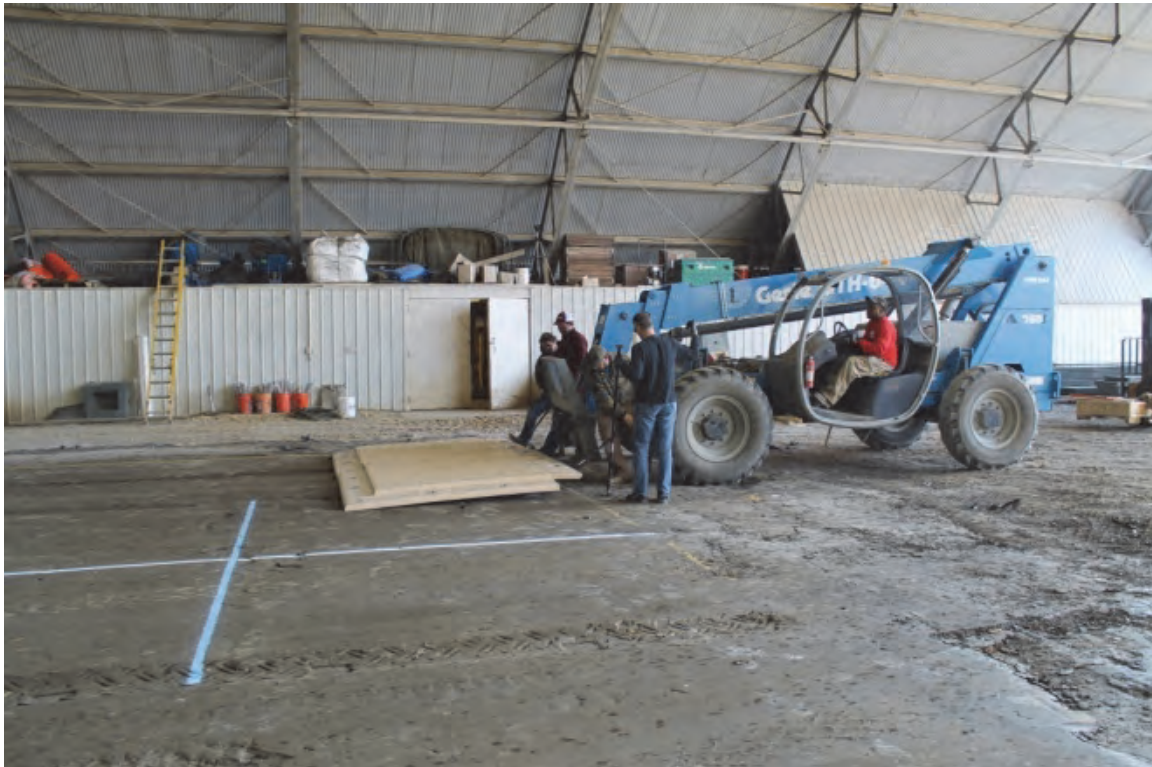
Figure 12. Positioning MegaDeck™ panel with an all-terrain forklift.

The MegaDeck™ panels required MHE for installation. Panels were removed from the shipping pallets by an all-terrain forklift and were carried into position on the CH test bed as shown in Figure 12. No geotextile was required prior to MegaDeck™ installation. Panels were assembled in a block array with continuous longitudinal joints according to manufacturer recommendations (MegaDeck™, n. d.). Panels were designed with underlap edges perpendicular to each other on two sides and overlap edges on the opposite sides. The overlap edges were positioned in the corner of the assembly so that the direction of construction was along the perpendicular underlap edges.

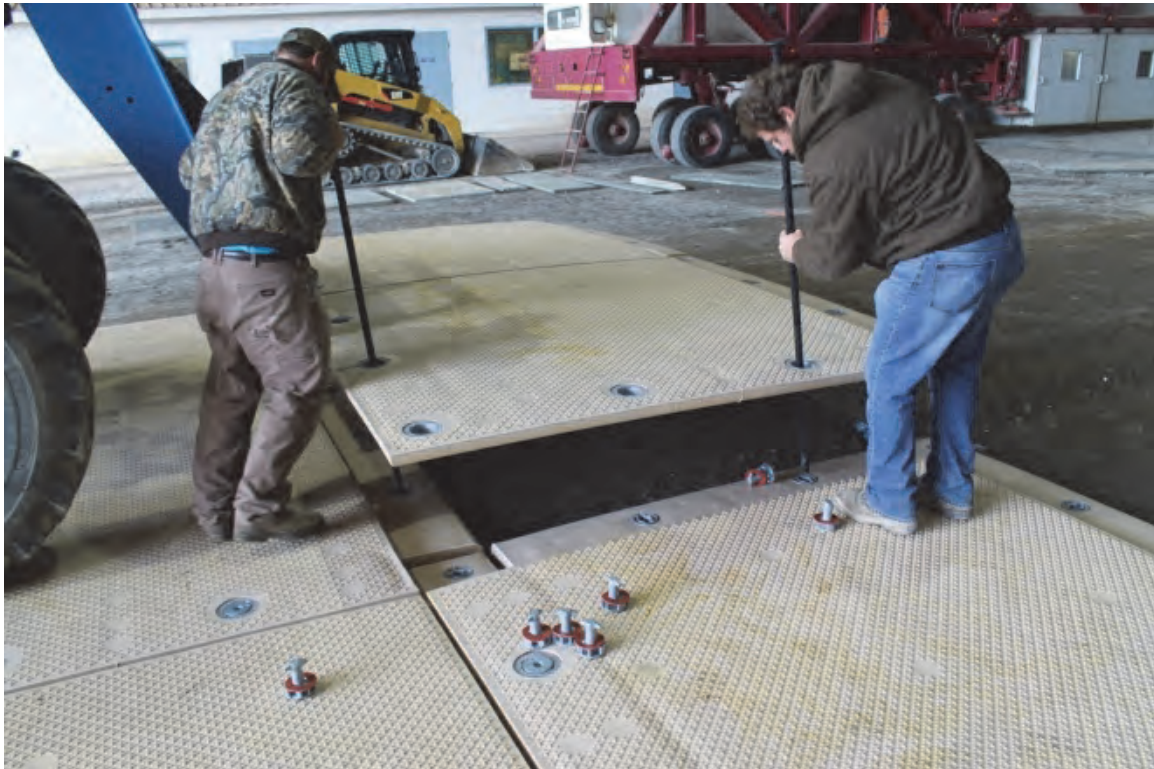
Figure 13. Guiding MegaDeck™ panels into position with guide rods.

The adjacent panels were moved to the test section by forklift. They were guided into position by inserting steel guide rods through connector holes in the overlap portion of the second mat and into the matching connector holes in the underlap edge of the first mat as shown in Figure 13. Once the second panel was on the subgrade, the guide rods were used as levers to adjust the position of the second mat so that connector pins could be easily

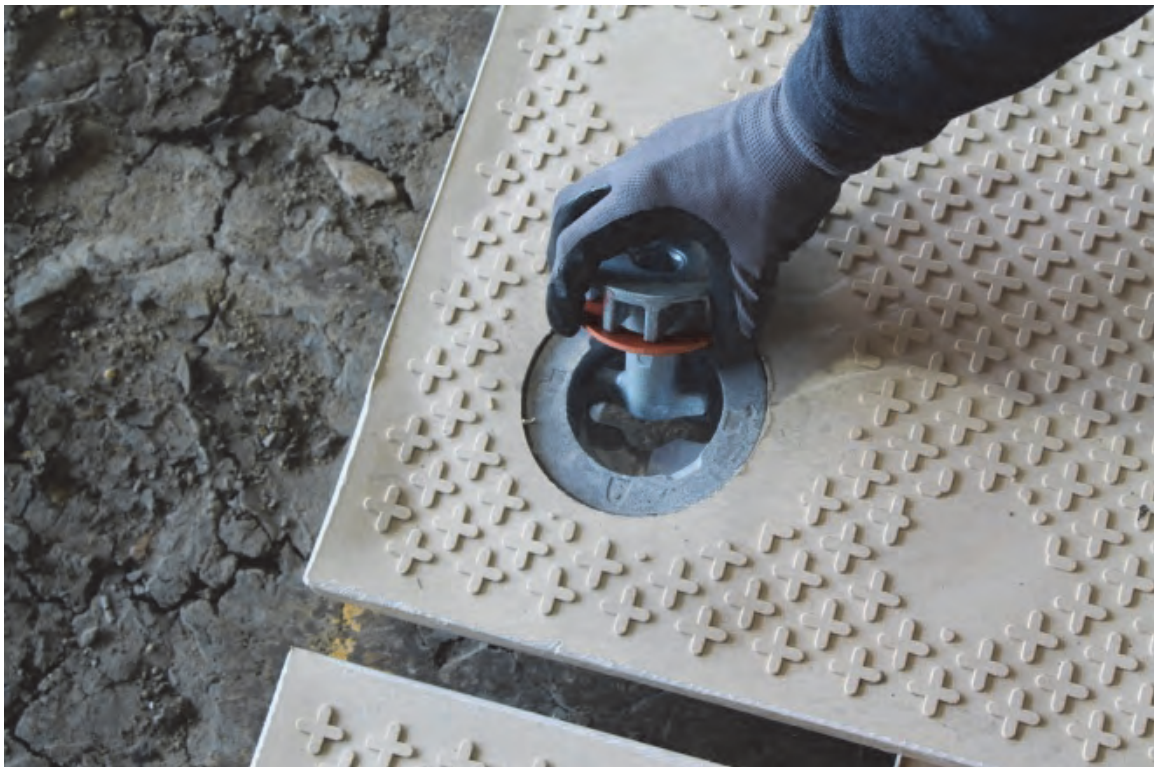
Figure 14. Installing MegaDeck™ connector pin.

inserted into the matching connector holes in the two panels as shown in Figure 14. Once the connector pins were inserted into the provided slots, a specialized T-handle tool was used to rotate the locking pins 90 deg and lock the two panels together as shown in Figure 15. Eight connector slots were supplied for each mat panel. This process was continued until the entire panel array was complete. During installation, the manpower was divided as follows: one forklift operator carried the panels into position, two men used steel guide rods to position the mats, and two men inserted locking pins into the connector slots and locked them into place with the supplied T-handle tool. After one hour of installation, the array of panels was complete. Assembly time was calculated and resulted in approximately 305 ft²/man-hr. Additional efficiencies were gained as the forklift operator and installers became more familiar with the procedure. A photo of the final layout of the MegaDeck™ test section is shown in Figure 16.

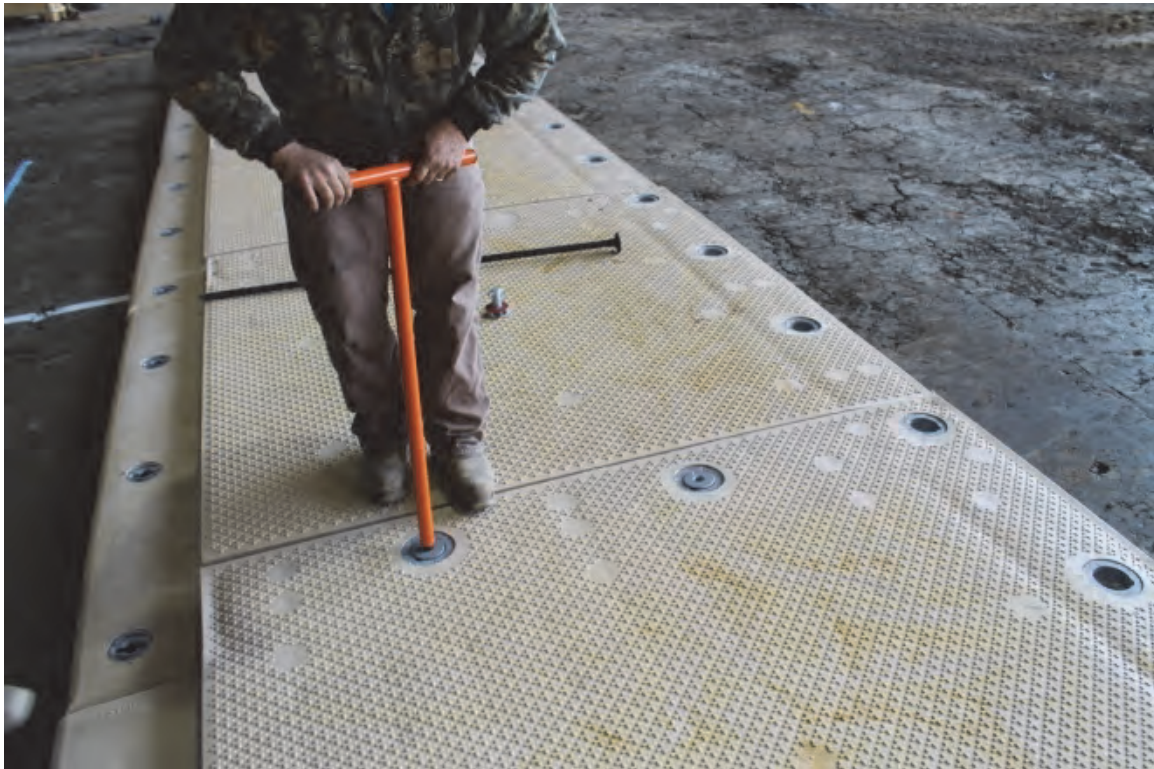
Figure 15. Locking MegaDeck™ connector pins with T-handle tool.

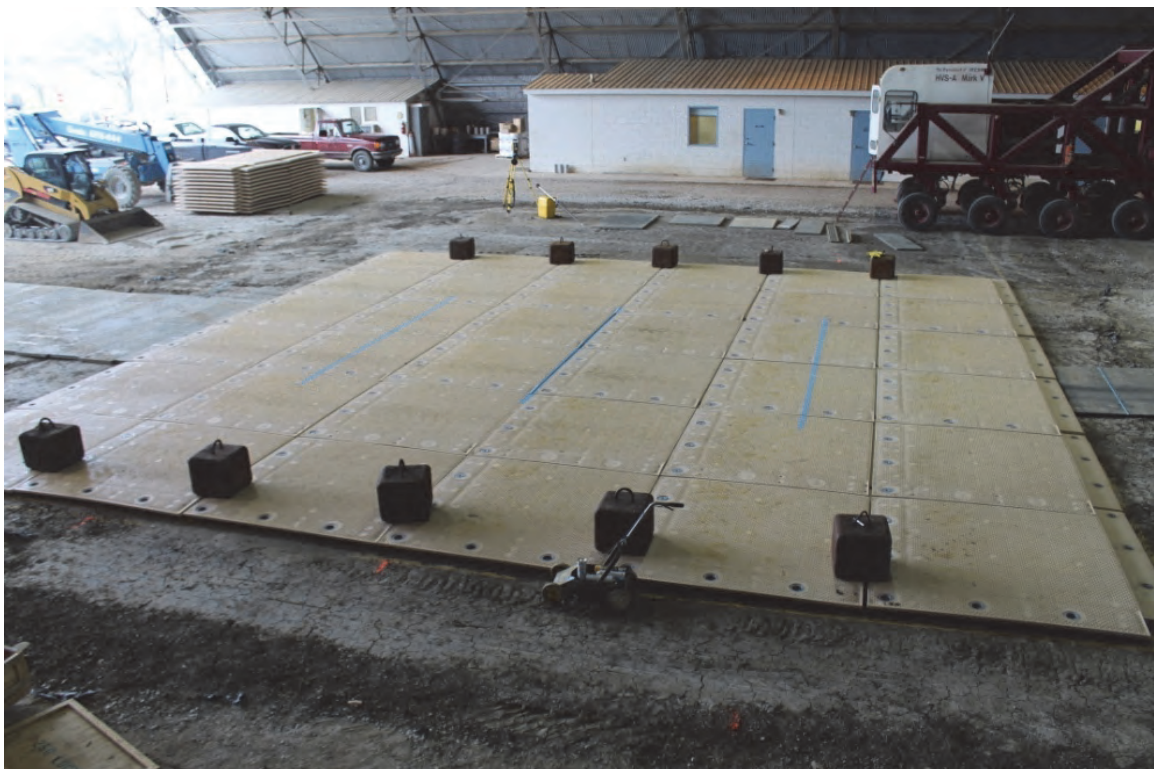
Figure 16. Final layout of MegaDeck™ test section.

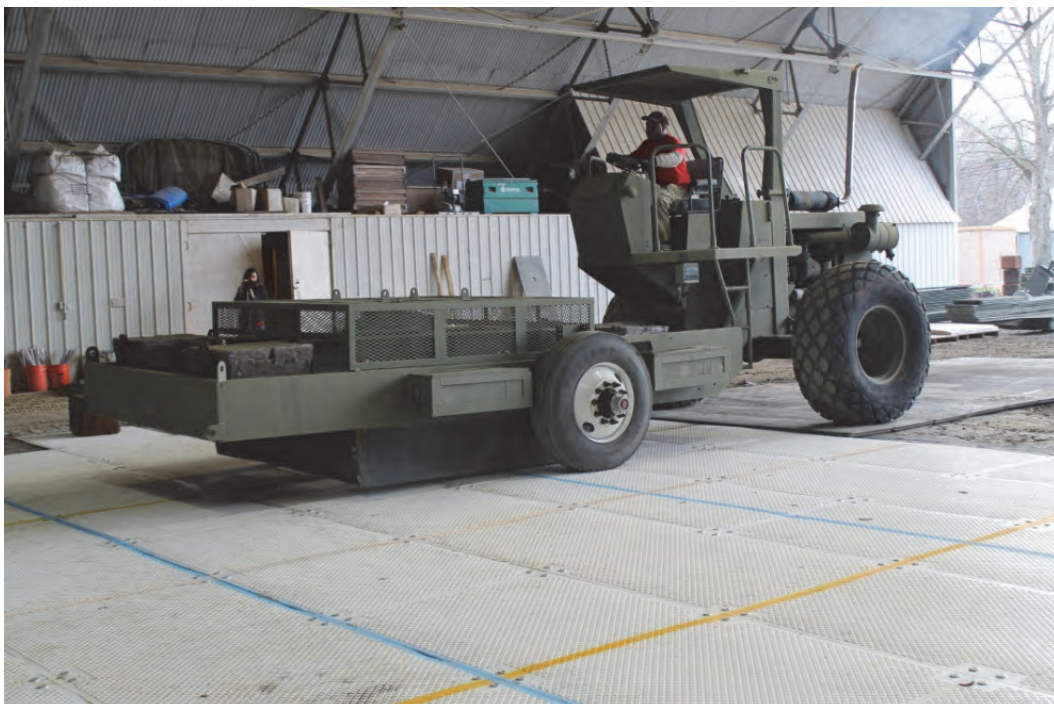
Figure 17. Simulated F-15E load cart.

The F-15E model is the most damaging aircraft in USAF inventory to pavement surfaces because of its high tire pressure and heavy single-wheel loading. A fully armed F-15E has a gross weight of 81,500 lb and a single-wheel loading of 35,235 lb with a tire pressure of 325 lb/in². This gross vehicle weight and wheel load are not representative of aircraft using a temporary hangar facility; therefore, the load was reduced from maximum gross weight to a standard weight of 68,500 lb to represent an un-armed aircraft. The resulting single-wheel load was 29,395 lb. A simulated F-15E load cart, equipped with an F-15E tire and wheel assembly, was loaded to the required weight and used for trafficking. This load cart, shown in Figure 17, was specially designed to test both pavement and matting surfaces to determine aircraft compatibility.

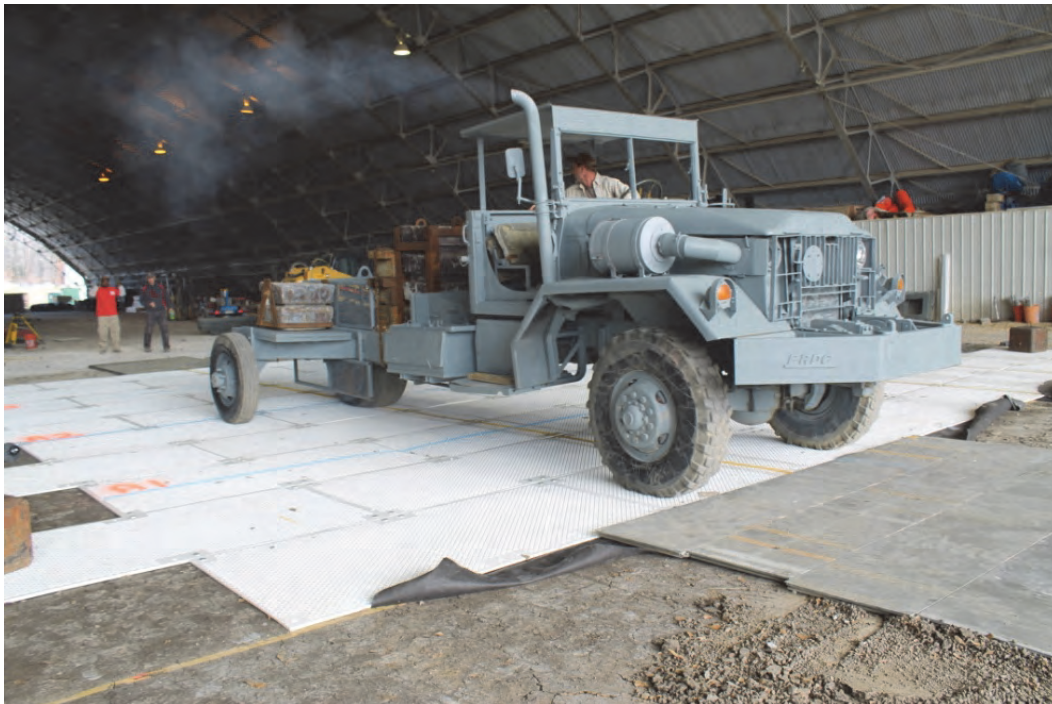
Figure 18. Simulated 25 kip forklift load cart.

The heaviest wheeled vehicle believed to utilize the BEAR shelters is the 25 kip capacity forklift. Based on vehicle data, the front axle when lifting a loaded 20-ft ISO container is 59,560 lb with a single-wheel load of 29,780 lb and a tire pressure of 80 lb/in². The exact vehicle was not available for testing; however, a single-wheel C-17 load cart was used to match the required loading and tire pressure, as shown in Figure 18. The contact area of the tire might have differed slightly than that of the actual forklift; however, the test vehicle closely matched the specifications and should give comparable results in terms of determining compatibility. The test vehicle was specially designed to test both pavement and matting surfaces.

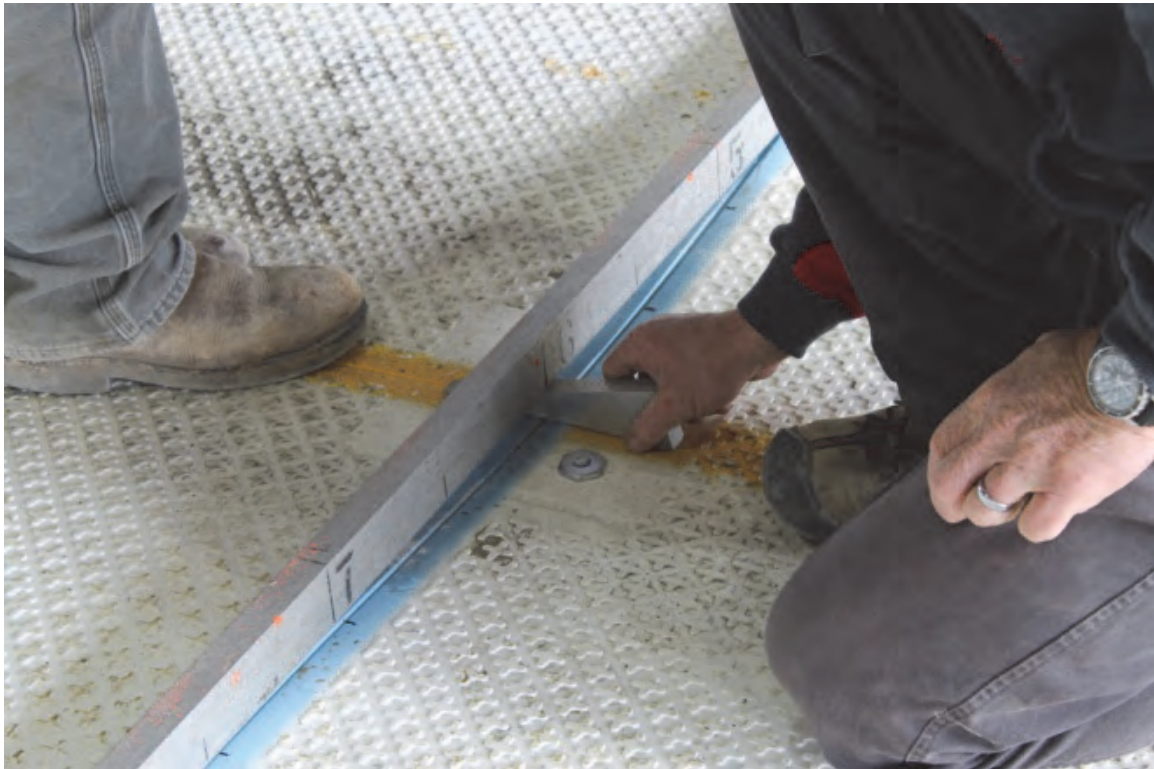
Figure 19. Measuring permanent deformation with straightedge.

Permanent deformation of the subgrade was monitored at intervals throughout trafficking. Two methods were used for observation as shown in Figures 19 and 20. First, a straight edge was placed across the traffic lane and then a ruler was used to measure the distance from the straight edge to the mat surface. Second, a robotic total station was used to record the changes in elevation along quarter-point lines painted transverse to the direction of travel during trafficking. The data collected were used to plot a profile of the deformation across the test vehicle's wheel path. The rate of deformation was recorded and is included in this report.

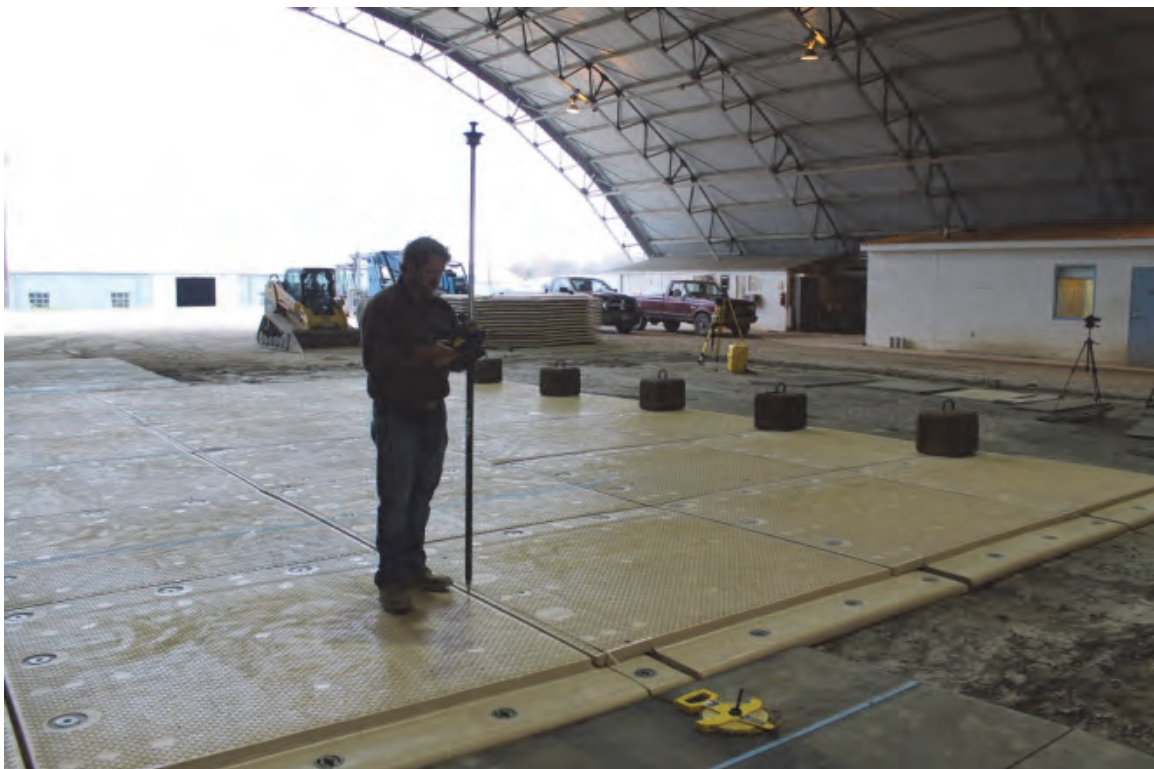
Figure 20. Measuring permanent deformation with robotic total station.

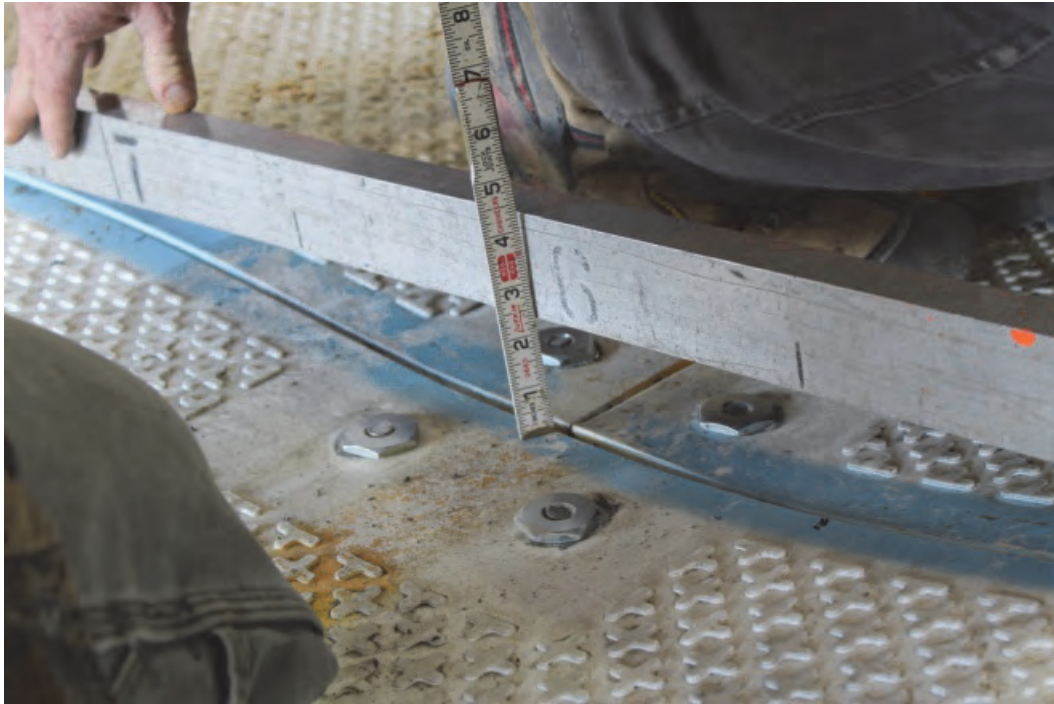
Figure 26. DuraDeck® final deformation on 25 kip forklift lane at connector plate location.

Simulated 25 kip forklift traffic was applied on the DuraDeck® matting system. After 30 passes, a deformation of 2 in. was measured. Since there is no failure criterion in terms of permanent deformation for wheeled vehicles, trafficking was continued. The deformation continued to increase until it reached 3 in. after 70 passes, as shown in Figure 21. At that time, excessive deformation on the surface caused the wheel guards on the side of the test vehicle to nearly touch the mat surface. To avoid damage to the test vehicle, the test was concluded. Although there was significant movement of the matting during trafficking and large deformation in the subgrade, no damage to the matting or connection system was noted. Applied stresses from protruding threaded studs caused a slight elongation of connector holes in the mat, but the panels could be reused without concern or modification. Photos of deformation on the mat after concluding trafficking are shown in Figures 26 and 27.

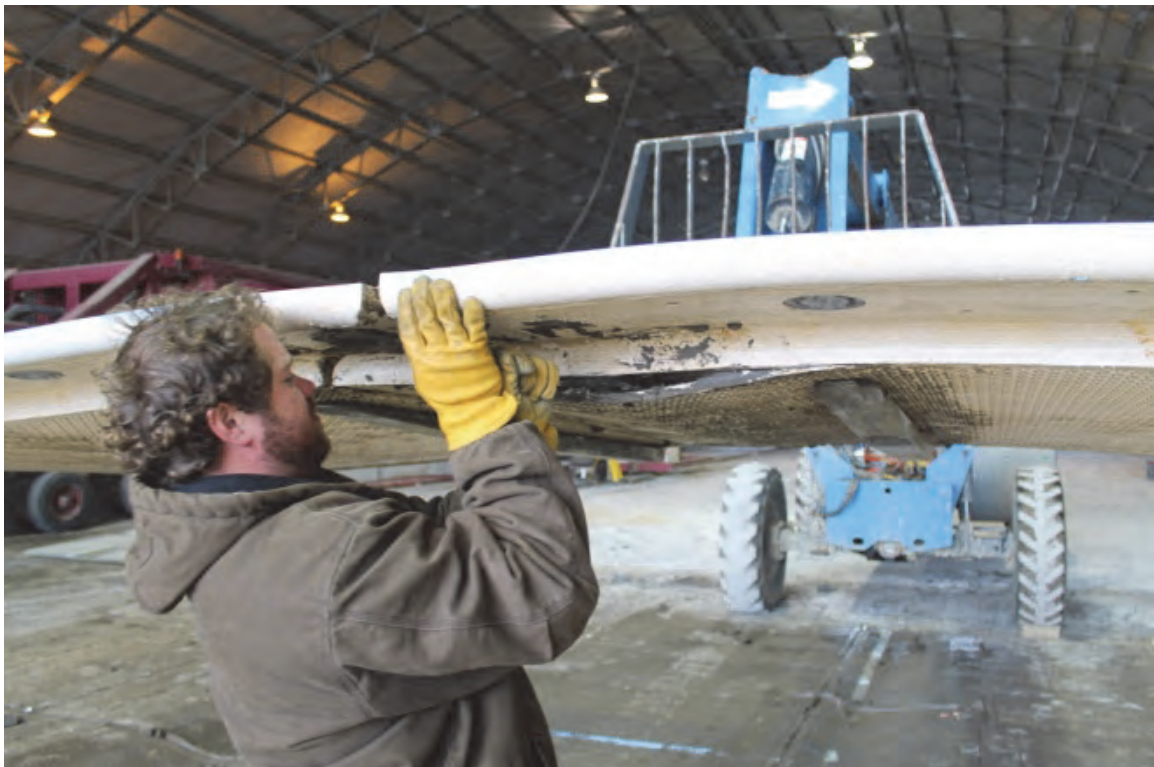
Figure 31. MegaDeck™ F-15E Lane 1 bottom skin damage.

after removal from the test section showed the bottom skin had begun to push through on the underlap side of the panels. This mat damage might have contributed to the rate of deformation in the wheel path. Figure 29 shows the final loaded deformation along the joint, Figure 30 shows a photo of the lane after trafficking was concluded, and Figure 31 shows a photo of the bottom skin damage.

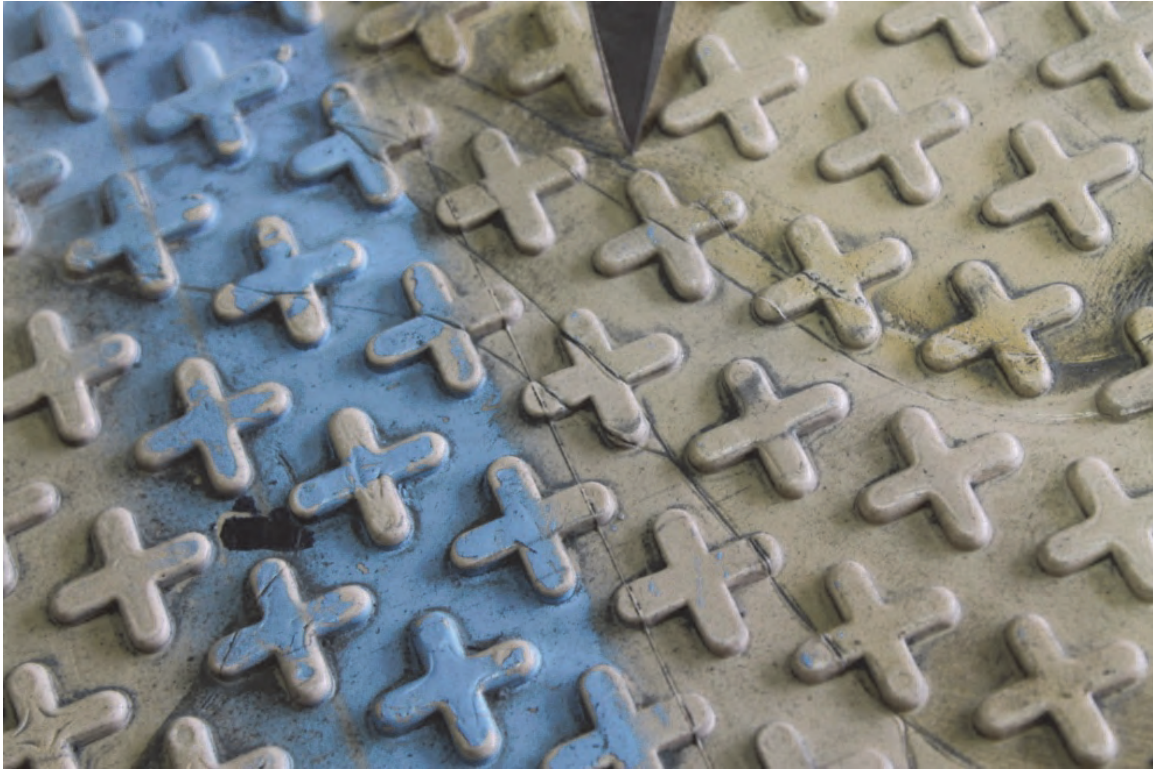
Figure 32. Minor cracking on MegaDeck™ after 400 passes on F-15E Lane 2.

Traffic was moved from Lane 1 to Lane 2 located between longitudinal joints to determine the difference in rates of deformation. After 32 passes, the permanent deformation was 1.25 in., and Lane 2 was considered to have failed by exceeding the deformation limits of the F-15E aircraft. Traffic was continued, since no breakage was noted. The deformation increased until 2.5 in. was measured after 400 passes. Minor cracking was noted on the surface of the skin, as shown in Figure 32; however, it did not pose a tire hazard. Trafficking was concluded to prevent instability of the load cart. The deformation on the surface caused the wheel guards on the side of the test vehicle to nearly touch the mat surface. The deformation on the mat surface after trafficking was concluded is shown in Figures 33 and 34. Lane 1 outperformed Lane 2, because the solid structure of the overlapping flanges

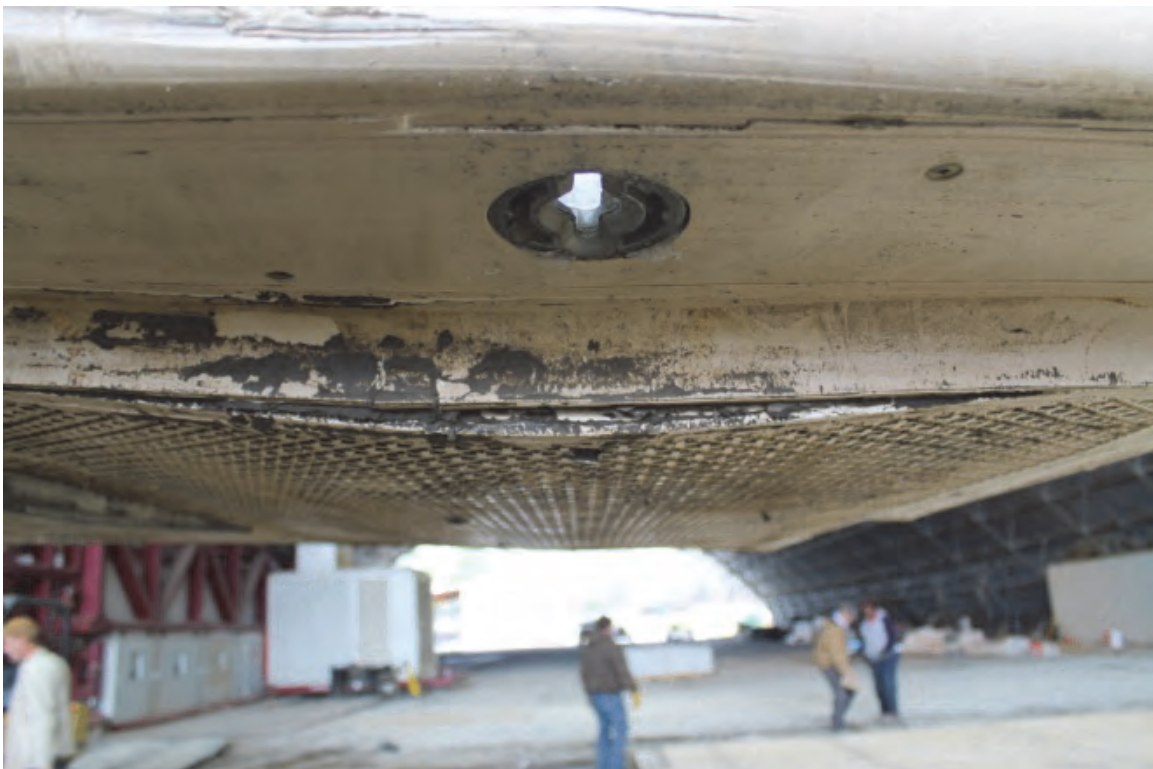
Figure 33. MegaDeck™ bottom skin debonding on F-15E Lane 2.

was able to handle the load better than the hollow structure of the mat's core. Once the MegaDeck™ panels were removed from the surface, researchers noted that the core of the individual panels had begun to crush, and the bottom skin was debonded from the panels as shown in Figure 35. Since this damage could not be seen from the surface and no tire hazard resulted, the actual number of passes before mat breakage occurred could not be determined. The damage resulted in earlier failure of Lane 2 over the central portion of the panels than Lane 1 with traffic along the joints.

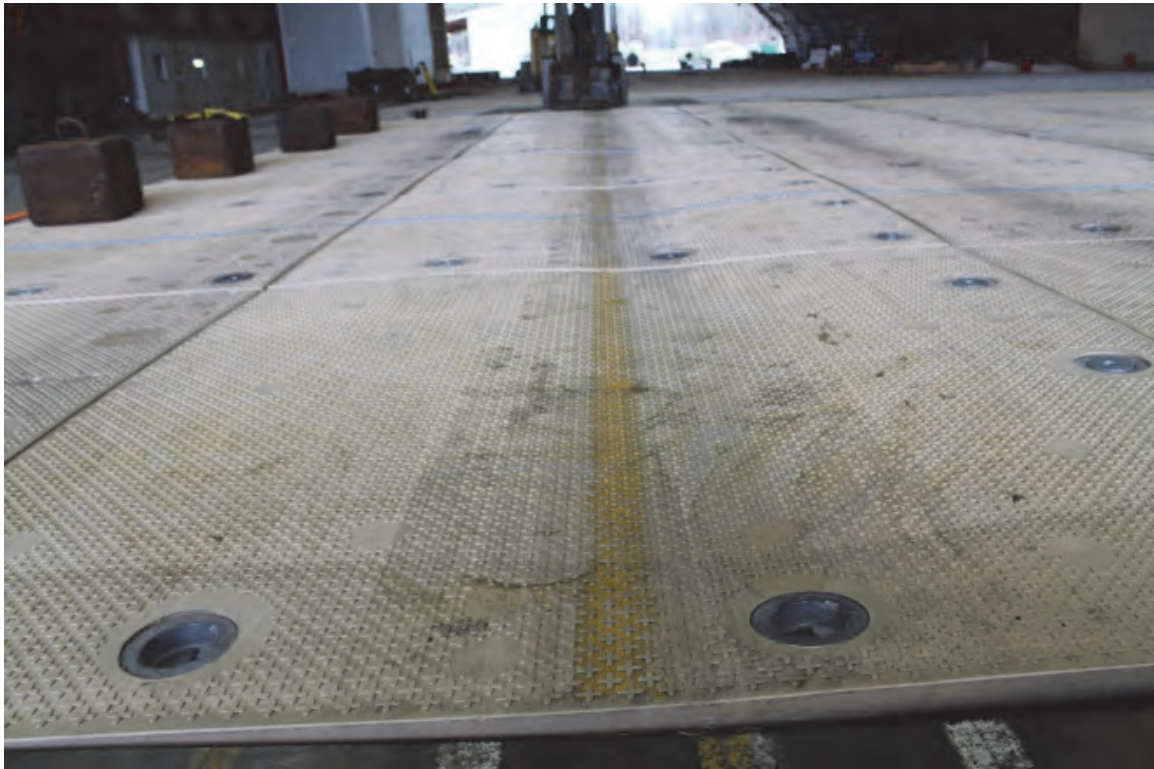
Figure 35. MegaDeck™ F-15E Lane 2 after trafficking was concluded.
